Front Porch Face Lift

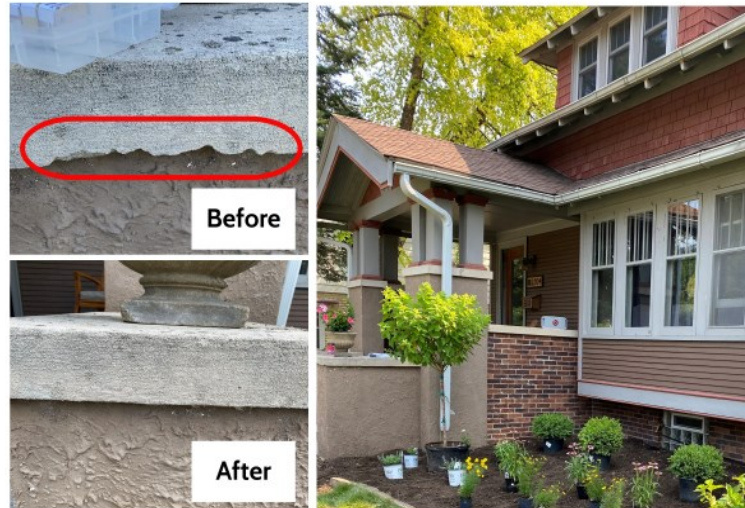
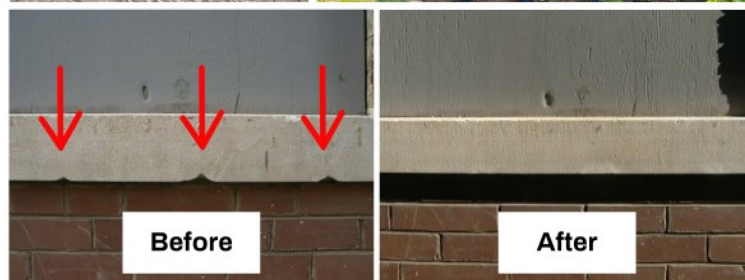
A home renovator has been buying, renovating and selling homes for years. He had recently purchased a home that needed a lot of aesthetic repairs to the front of the home. The limestone columns on the front porch had deteriorated over the years and the edges eventually started to chip away along with the concrete window sills.

A Bonstone Materials technician recommended using Historical Restoration Mortar (HRM), a lime-based patching mortar to repair the columns and window sills. After cleaning all the repair areas, he mixed and applied HRM using a trowel to several areas where stone had chipped or broken off. After letting the material set up for approximately 15 minutes, he used a razor blade to scrape away granules and smooth out the surface. No sanding was required and after letting it fully cure, the repair was complete.

The columns and window sills were restored back to their original condition not only giving the front porch a fresh new look, but also increasing the home's curb appeal. Not only was he thrilled that he was able to salvage the columns and sills without having to replace them but the fact that the repairs took less than an hour to complete, saving him time and money.
